Briefing Type: Lessons Learned

Lesson Learned No.: LL08-0009

Title: Defective Furniture Design Becomes a Hazard

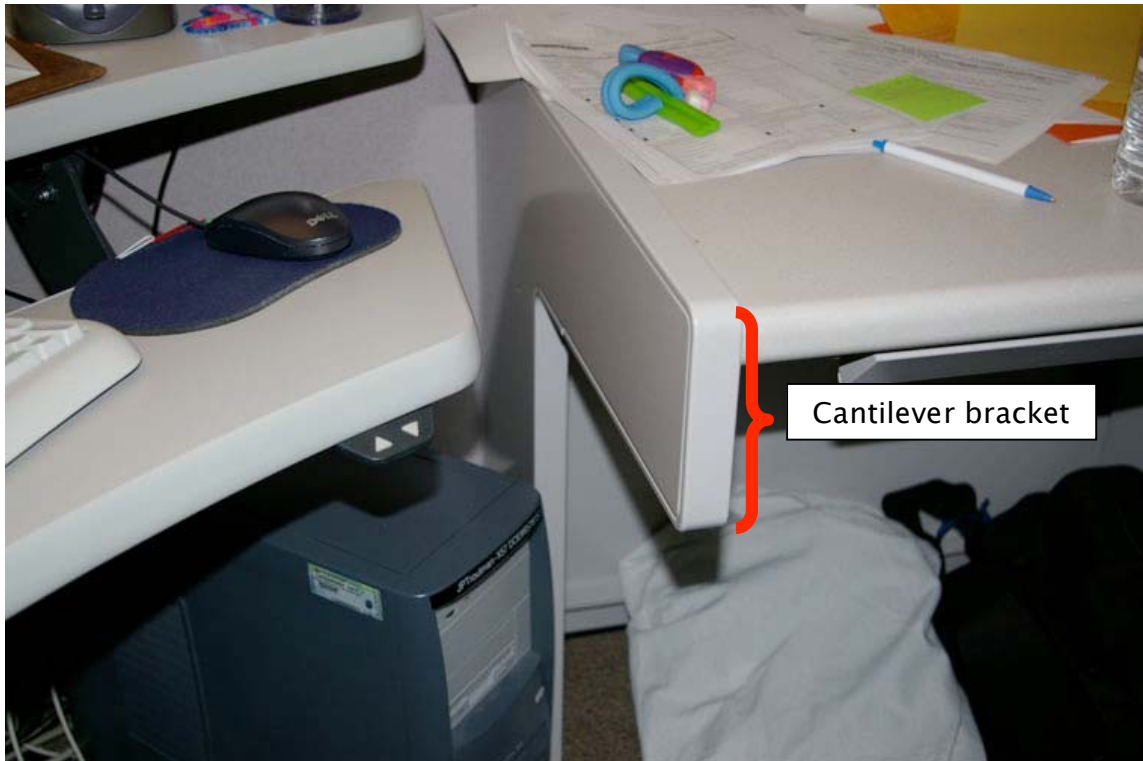
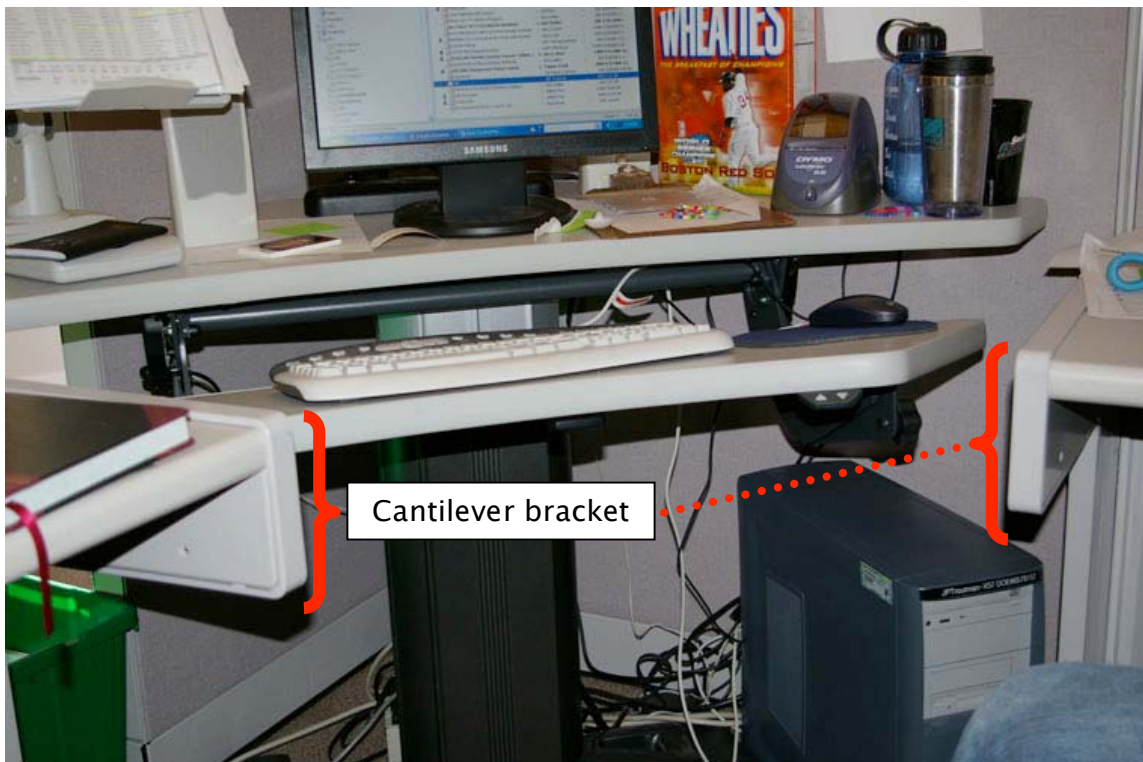
The employee's workstation includes a bi-level adjustable computer table in the middle, and two side tables, each with a 5.75-inch high cantilever bracket on the side "sandwiching" the computer table. It is the cantilever bracket of the right side table that the employee's right knee hit. The employee frequently uses a side table (typically the one on the right) to perform paperwork. Current ANSI standards specify a clearance of 26 inches for the knees for tall people (e.g., 95th percentile males). While the overall station complies, these cantilever brackets provide only a 24 inches clearance.

Example of the problematic furniture design (2 photos attached)

- (1) Presence of a 5.75-inch cantilever bracket on the side table relative to height of employee on chair.
- (2) Turning rapidly in chair while moving from working on computer table to the side table.
- (3) Using a chair mat underneath a chair that is equipped with special carpet casters (designed to roll easily on carpet) might have added speed to the rolling.

- (1) Ergonomic evaluations should include evaluation of knee space and free movement under the workstation.
- (2) Advocate vigilance about leg movement underneath different work surfaces. People with longer legs will have more problems with certain furniture.
- (3) Procure and install office furniture that has been designed and constructed with adequate clearances per ANSI standards.
- (4) Chair casters should be matched for the surface on which they will be used. Do not use a chair mat if the chair comes with special carpet casters.
